## Challenge

Damage from erosion and cavitation required three week's of repairs to address welding and grinding.

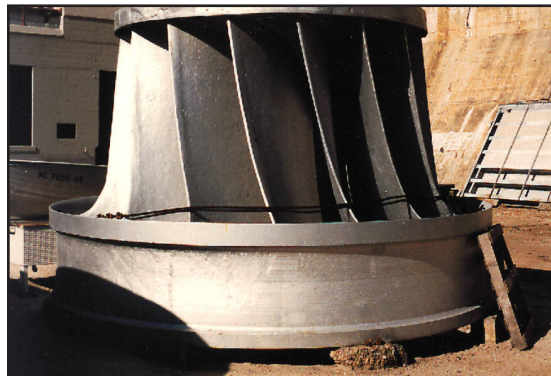
Vanes of turbine were eroded and impacted due to high suspended solids content in water and cavitation from low flow.

A Francis turbine prior to coating

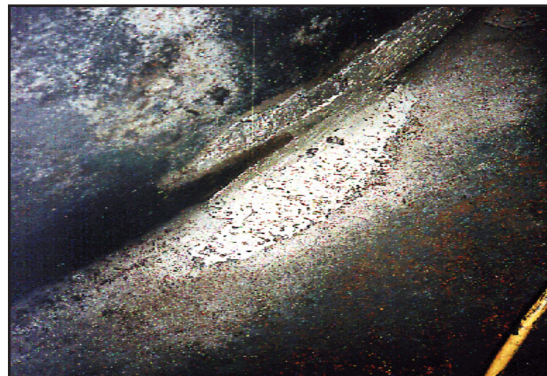
Cavitation damage is evident after proper surface cleaning

- Abrasive blast surface to Sa 2.5 with 3 mil (75 µm) angular profile

1. Apply **ARC 858** to the cavitation affected areas, rebuilding any metal loss
2. A subsequent top coat system using two alternating color coats of **ARC 855** applied for a smooth surface finish

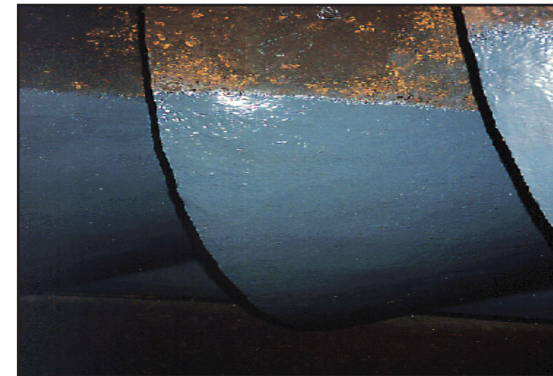
Top coat of ARC 855 on the cavitation affected blades

- ARC coating solutions reduced maintenance from 21 days per year to 3 days per year
- While cavitation still occurs, only the coating is being damaged which can be quickly and easily repaired
