## Challenge

Provide a viable alternative to existing method to protect the structural integrity of a fiber flow drum.

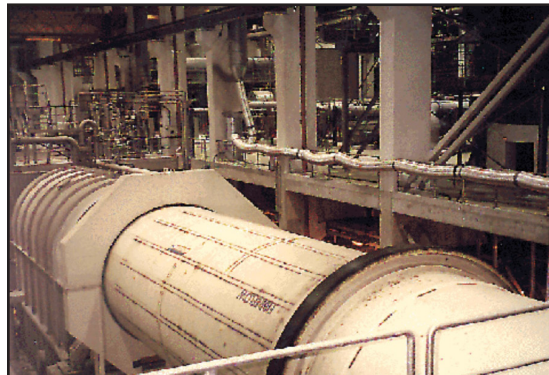
A combination of mechanical stress, corrosion at the weld seams, and abrasion induced metal loss weakened the structural integrity of the flow drum. The longitudinal vanes were particularly damaged.

Fiber flow drum

1. Apply **ARC 858** to the weld seams to build up irregularities, pits, and damage. Curve out angles and corners too prevent pulp collecting on longitudinal vanes
2. Apply **ARC 858** as a topcoat to provide corrosion protection over a larger area and to reduce surface friction

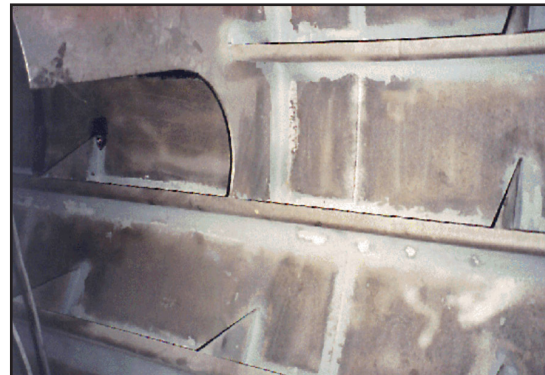
Weld seam grit blasted awaiting coating

Abrasive blast to Sa 2.5 with 3 mil (75 µm) angular profile

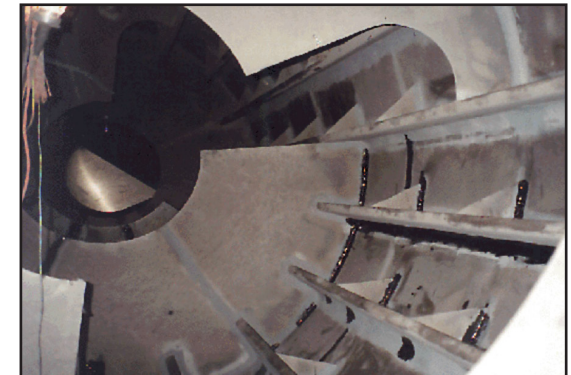
ARC 858 and ARC 855 being applied to weld zones
