Challenge

After 50+ years in service, existing wicket gates were showing evidence of severe damage, which was impacting the performance of the turbine.

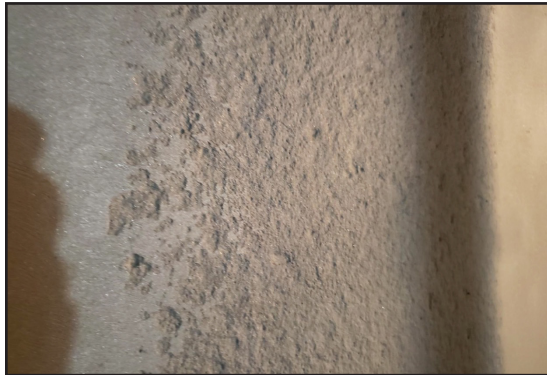
Entrained solids and cavitating exposures were causing the damage.

Damage to wicket gates.

To provide a new erosion-resistant protective liner with high build and edge-retentive properties that would help to prevent further damage to the wicket gates.

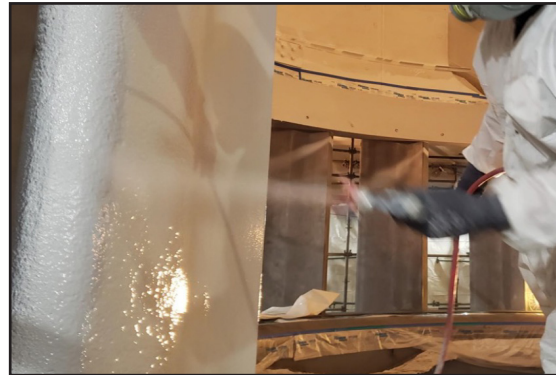
Chesterton® ARC S1HB was applied by a plural component spray system at a DFT of 120 – 150 mils to >4000 ft² of surface area.

Plural component spraying of ARC S1HB up to 150 mils in a single coat.

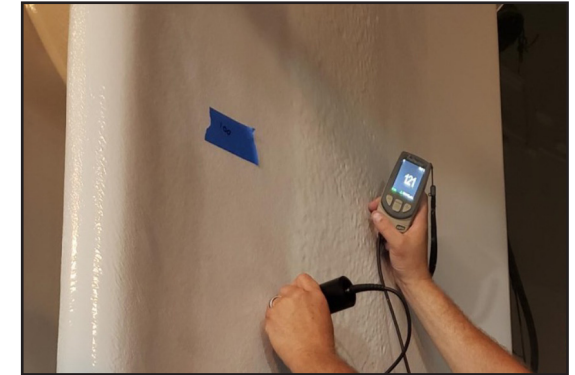
Measuring DFT at 120 mils.
