A hydropower plant using Kaplan turbines noticed that their blade runners were not working at optimum efficiency due to leakage of the blade runner seals.

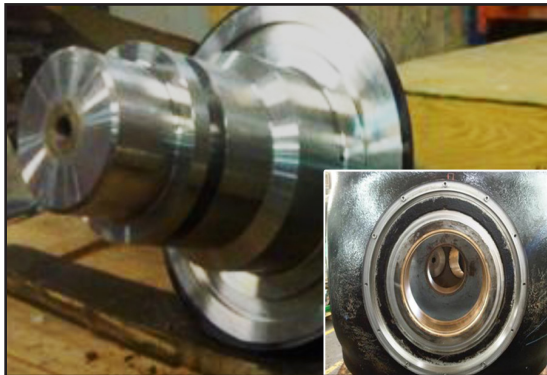
Failing OEM rubber stacked v-rings had to be replaced every few years leading to lost downtime and unplanned maintenance.

Equipment showing internal housing and blade runner.

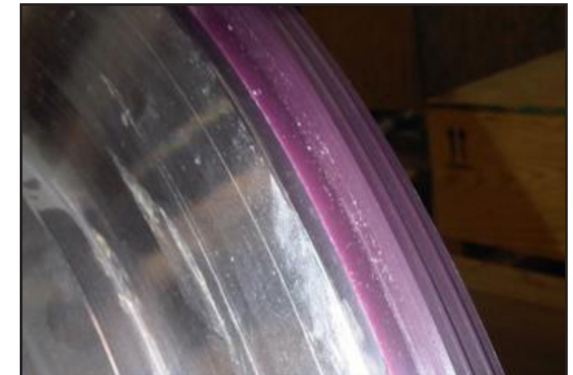
Chesterton 22KN products shown installed onto the blade runner hardware.

Use two **Chesterton 22KN** seals back-to-back, creating a positive seal both internally and externally.

- Helped the customer get the equipment up and running quickly, saving valuable time and money.
- Zero leakage for over 4 years, eliminating the environmental and safety concerns, as well as associated costs.
- Blade runners are working at optimum efficiency.
