Challenge

Customer was considering replacing lower section of stack liner due to severe flue gas induced corrosion. Replacement cost and unscheduled downtime was estimated at \$500K.

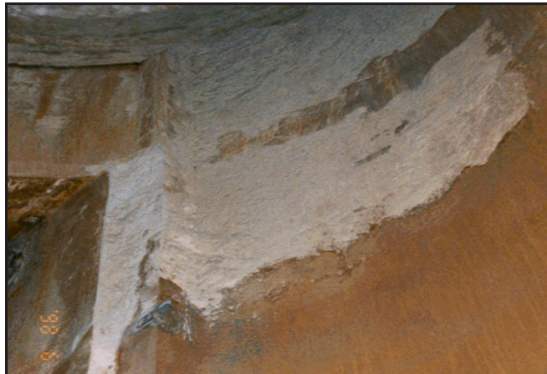
Condensing flue gas was generating corrosive acid concentrations on unprotected steel.

Severe corrosion inside the stack

- Mechanical removal of scale and corrosion with scrapers
- Power wash to remove invisible salts in metal
- Grit blast to Sa 2.5 with 3 mil (75 µm) angular profile

1. Apply **ARC S7** stripe coat to weld seams
2. Apply 2 coats of **ARC S7**, total ~DFT: 40 mil (1.0 mm)

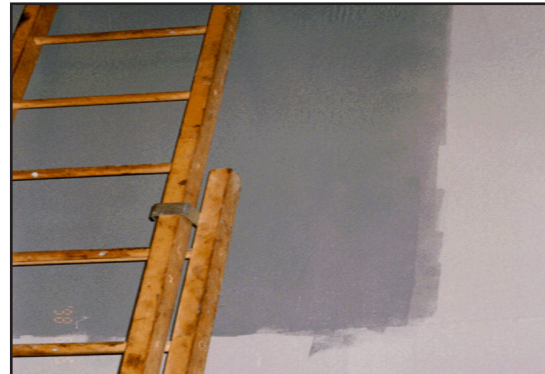
First coat of ARC S7

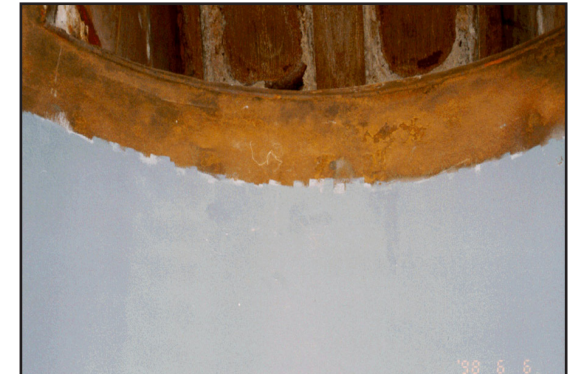
Second coat of ARC S7 applied, completing the project

- **ARC S7** prevents corrosion of remaining metal
