Challenge

Issue

A major mine owner was experiencing premature failure of the arm cylinder on a Demag excavator leading to unplanned downtime and lost production.

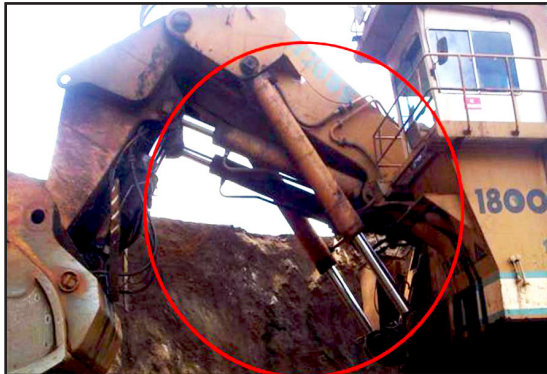
The OEM rubber seals were leaking shortly after installation. Severe leakage led to replacement, on average, after only 48 days.

Upon inspection, the wiper and rod seals were found to be damaged and could not withstand the severe hocking loading this equipment was exposed to.

Demag excavator – Model H485.

Chesterton's local specialist recommended a cylinder upgrade solution that included a high-performance wiper used in combination with a rod seal and anti-extrusion ring.

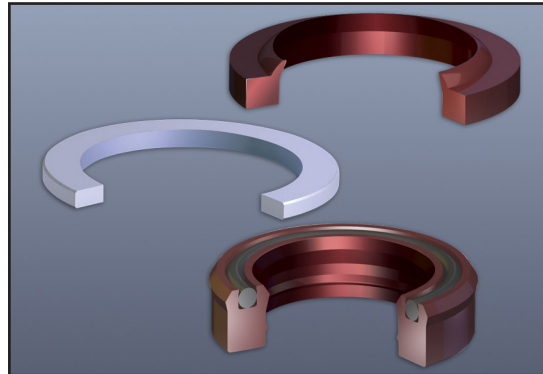
- **21K** - Positive-rake profile effectively wipes away contaminants and protects the equipment
- **22KE** - Energized dual component seal for added stability withstands shock loads
- **9K** - Anti-extrusion ring protects seal from extruding while under pressure
- **AWC 800** - Thermoset polymer, durable wear, and ultra-violet ray-resistant material

21K - 150 x 167 x 159 x .9 mm red polymer.

22KE - 150 x 168 x 14,80 mm w/ 9K back up ring.

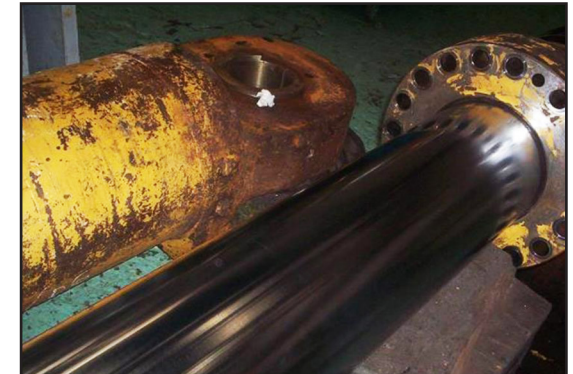
The Chesterton sealing solution extended the rebuild cycle from 48 days up to 160 days during the evaluation period by the mine.

Arm cylinder was in excellent condition upon inspection.
