Challenge

Issue

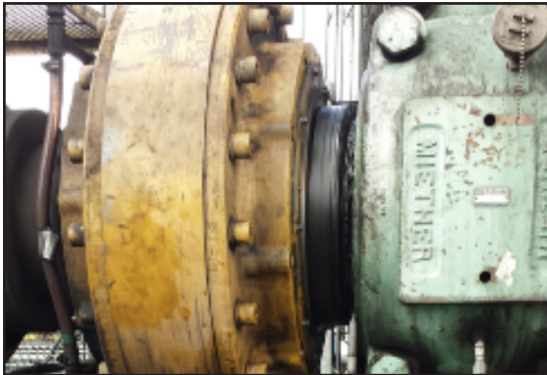
- A client experienced continuous oil leaks after startup on a conveyor gearbox.
- Contamination was entering the bearing housing, resulting in frequent seal changes and considerable downtime costs.
- The seals lasted only four weeks.

The plant's conveyor equipment leaked excessively.

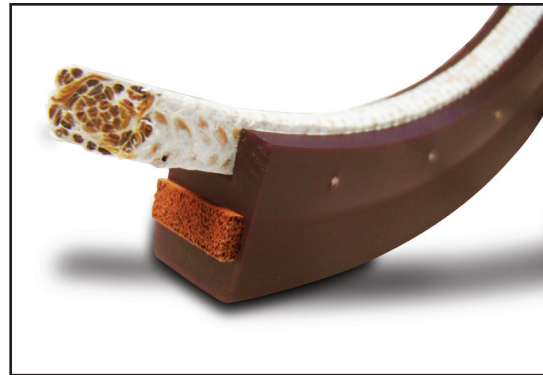
Chesterton Matrix Rotary Seal combines two materials for exceptional performance.

A Chesterton representative installed two **Chesterton Matrix Rotary Seals**:

- One faced the bearing to seal lubrication.
- The other faced the retainer ring to prevent outside contamination from entering the bearing housing.
- Both seals were installed rapidly without the need for disassembly of equipment, thereby minimizing downtime.

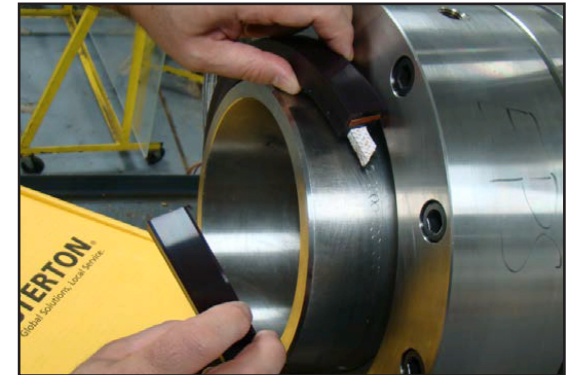
The **Matrix Seal** installation is very simple and fast.
