Challenge

A mixer OEM was experiencing high-visibility seal failures at a key pharmaceutical customer where numerous additional mixers were to be purchased. The concern was that the seal failures could be associated with the mixer manufacturer and multi-million dollar mixer orders could be lost.

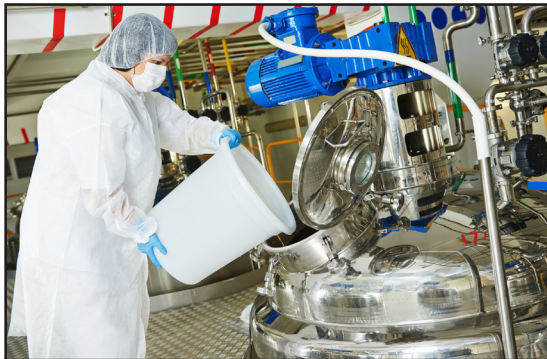
Mixer was experiencing short seal life.

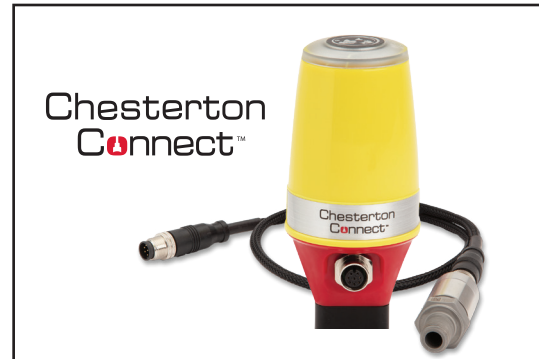
A **Chesterton Connect IS Certified Sensor** was installed on a problematic mixer as well as a new seal. A second **Chesterton Connect IS Certified Sensor** was also installed on another mixer. A standard **Chesterton Connect Gateway** was installed outside of the hazardous area to automatically send the measured parameters to the Chesterton Connect Cloud for 24/7 remote monitoring and notifications.

Chesterton Connect IS Certified Sensor.

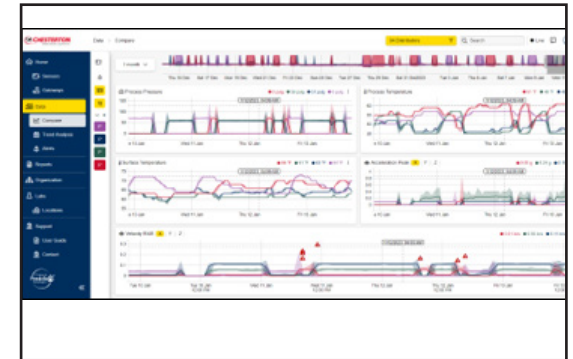
Once the **Chesterton Connect IS Certified Sensors** were installed, repeated and constant vibration alerts were sent to the engineering manager's phone the first evening. The operators discovered that they may have been starting the mixers prior to proper liquid levels.

Chesterton Connect data helped solve the seal failure problems.
