## Challenge

A chemical plant was experiencing an unusually high failure rate for single cartridge mechanical seals on a 65% Nitric Acid Transfer Pump application. At the time, the Mean Time Between Repair (MTBR) was only 1.2 months.

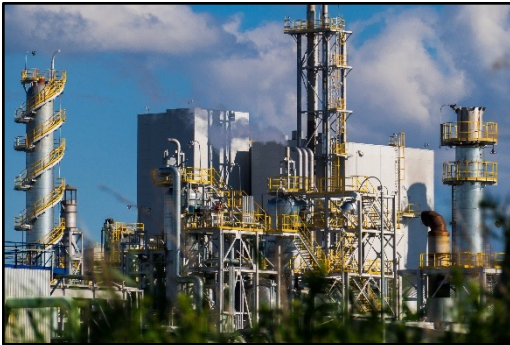
Our seal analysis revealed square, hardened O-Rings and seal faces with a heavy wear track. These symptoms typically point to dry running of the pump. However, the customer checked the operation of the system. All controls were in good working condition so dry running was very questionable. A specialist observed the installation of the seal and found that the customer was doing it correctly. There were no noticeable issues with the operation of the pump.

The pump seal failure occurred nearly every month.

Within a few days, the team gathered enough data from Connect to identify negative pressure in the seal chamber when the pump was running. In turn, this pressure caused the mechanical seal to show classic dry run symptoms...square, hardened O-Rings with heavy seal face wear tracks.

After conducting a system audit, the customer was able to throttle back a valve to ensure proper flow from the pump. The pump and mechanical seal are now running properly and the projected MTBR has improved to more than 24 months!

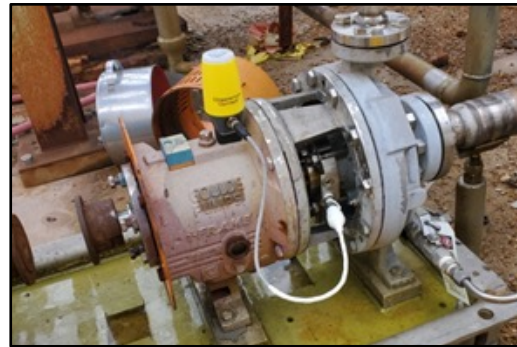
Chesterton Connect installed on the pump.
