# Pneumatic Paper Roll Lift Cylinder Retrofit Provides 2+ Years Reliable Performance

Pulp and Paper  
Chesterton 28K V-Ring Set  
Case Study 039 Fluid Power

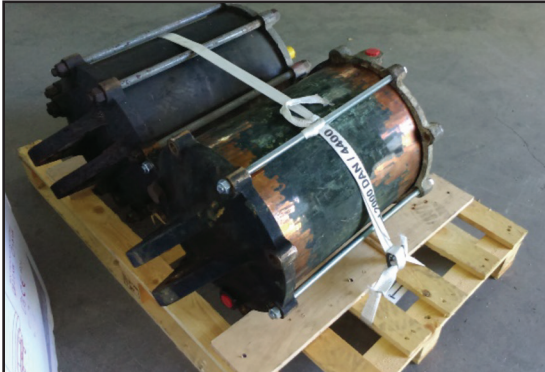
Cylinder rods and bores were scored, scratched. Rod and piston seals were leaking, causing pressure loss and sliding down or hopping of the cylinders.

Cylinder prior to repair

A complete cylinder upgrade, including replacement of the cylinder tube, redesign of the seal system and upgrading profiles materials.

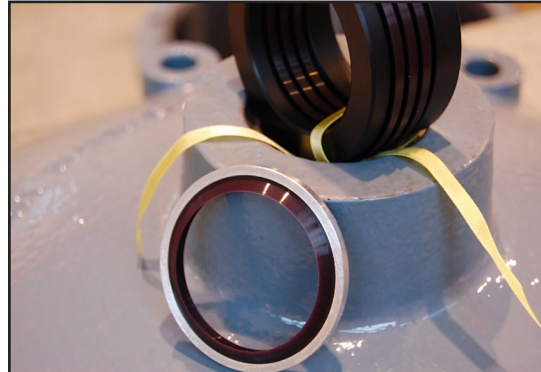
- **CW21K:** Positive-rake profile effectively wipes away contaminants and protects the equipment
- **R28K:** Split, multi-lip design provides tight, leak-free operation
- **16K Wear Rings:** Provides guide for the rod and eliminates metal-to-metal contact
- **AWC800 Seal Material:** Chesterton's thermoset polymer, durable wear, and hydrolysis resistant material was used for durability.

Seals to be installed in the rod gland

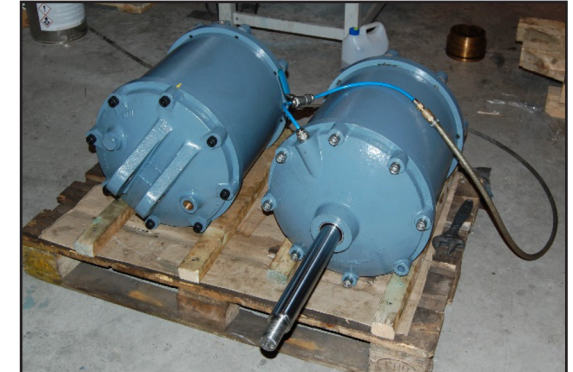
Smooth operation of the cylinders provides an accurate positioning of the rolls, without a sliding down or hopping motion. The upgraded cylinders have been in operation since December 2016 with leak- and trouble-free operation.

Cylinder after repair
