Challenge

A paper mill was having leaking issues from the gland bolts on a 4.25" washer vat re-pulper used to break down defective paper to then be reprocessed.

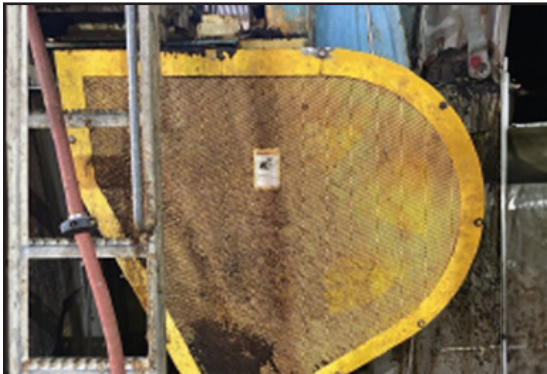
Front view of stuffing box with safety guard during operation.

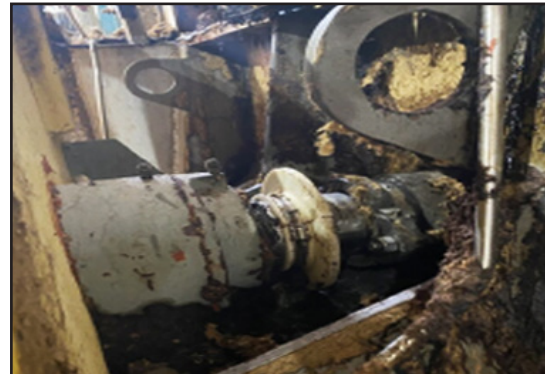
The gland bolts were difficult to access, making packing adjustments challenging and safety a concern while equipment was running.

Equipment before **AMPS unit** installation. It was very difficult to access bolts to make any adjustment, and unsafe to do while running.

- Three rings of ½" **Chesterton 377 CarbMax™ packing** were installed.
- Two bolts were fitted with **Chesterton AMPS™** double cylinder units and pressurized to 2 bar g (30 psi).

The addition of a pressure regulator allowed for adjustments to be made from outside the safety guard and helped ensure equal pressure was applied to both bolts.

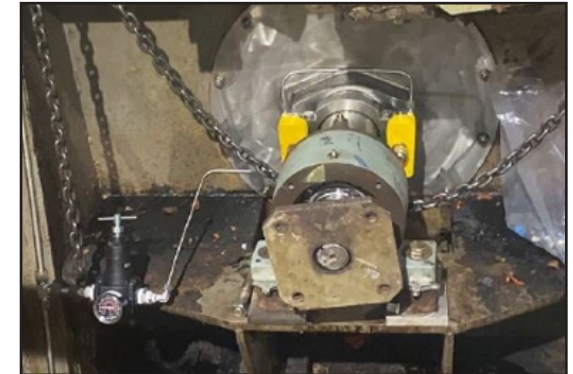
After installation and equipment restart, the **AMPS technology** helped seal the equipment with minimal leakage.

Equipment with **AMPS units** installed on both bolts, enabling constant, even loading and offering the ability to safely make adjustments.
